Photovoltaic power plant inspection report
FVE - nová instalace na střeše

Report reference number: 39843

According to: IEC TS 62446-3

Inspection date and time: Friday 2024/02/16
16:15

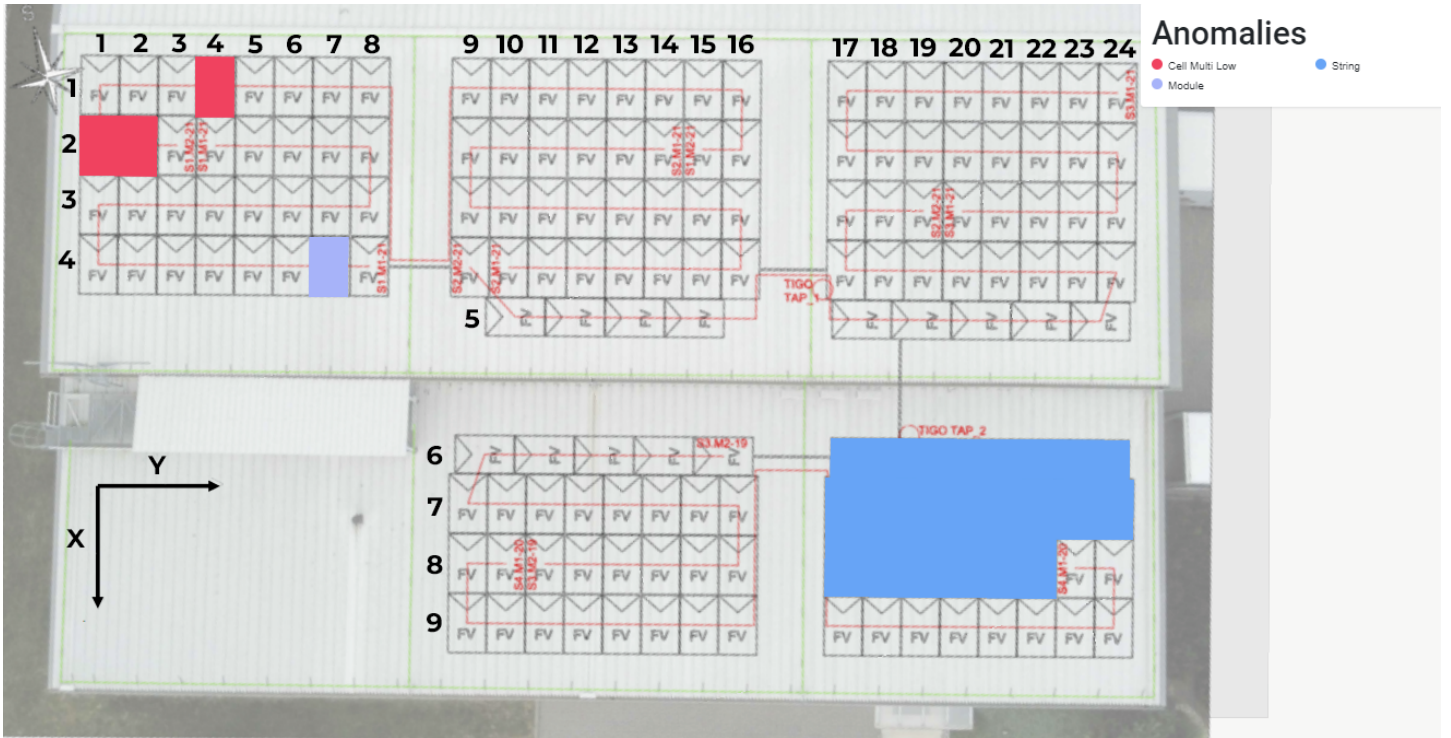
Anomaly map

The following anomalies were found on the panels of the inspected photovoltaic power plant, with a total of **5 on 23 modules**.

Primární fotka	Sekundární fotka	Anomaly name	Row X,Y	String X,Y	Module X,Y	Priority	Delta T	Proposed next action
 	 	Module	0,0	0,0	4,7	High		Repair
 	 	Cell Multi Low	0,0	0,0	2,2	Low	6.9	Tracking
 	 	Cell Multi Low	0,0	0,0	1,4	Low	3.9	Tracking
 	 	Cell Multi Low	0,0	0,0	2,1	Low	1.9	Tracking
 	 	String	0,0	0,0	6,17	High		Repair

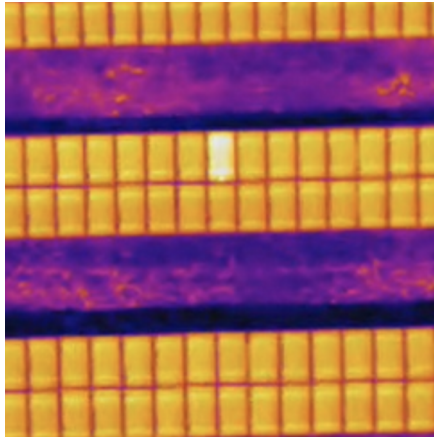
Module

The temperature of the entire module is high compared to the surrounding area.

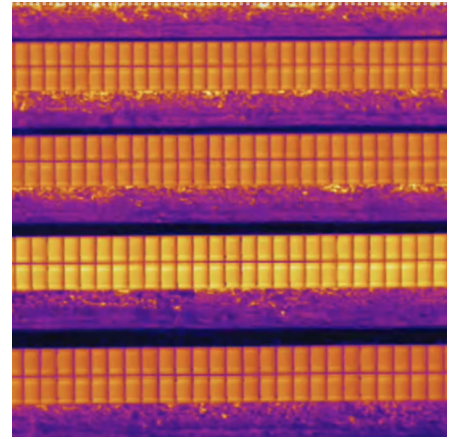
String

A string-type anomaly affects several modules connected in the string simultaneously. The string anomaly indicates a fault in adjacent modules corresponding to the string layout and impacts all modules within the string.
