Photovoltaic power plant inspection report  
**FVE - nová instalace na střeše**

**Report reference number:** 39843

**According to:** IEC TS 62446-3

**Inspection site:** FVE - nová instalace na střeše

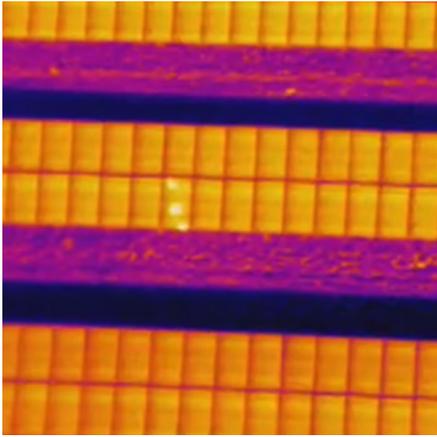
### Cell Multi Low

Overheating of a group of cells, where the anomaly area temperature is higher than the surrounding area, but not by more than 10 °C.

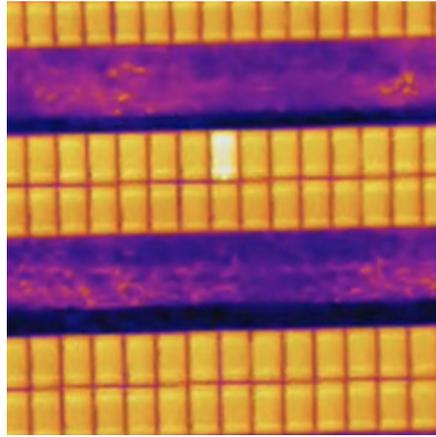
### Module

The temperature of the entire module is high compared to the surrounding area.

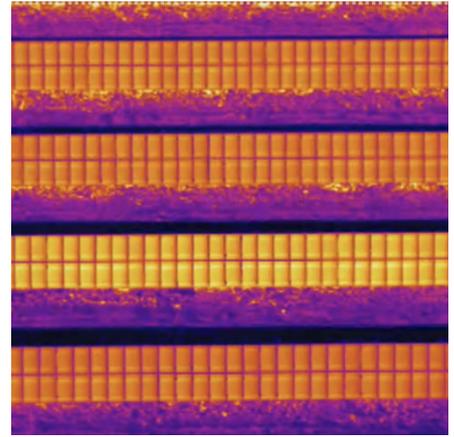
### String

A string-type anomaly affects several modules connected in the string simultaneously. The string anomaly indicates a fault in adjacent modules corresponding to the string layout and impacts all modules within the string.
