Photovoltaic power plant inspection report  
**FVE - nová instalace na střeše**

**Report reference number:** 39843

**According to:** IEC TS 62446-3

**Inspection site:** FVE - nová instalace na střeše

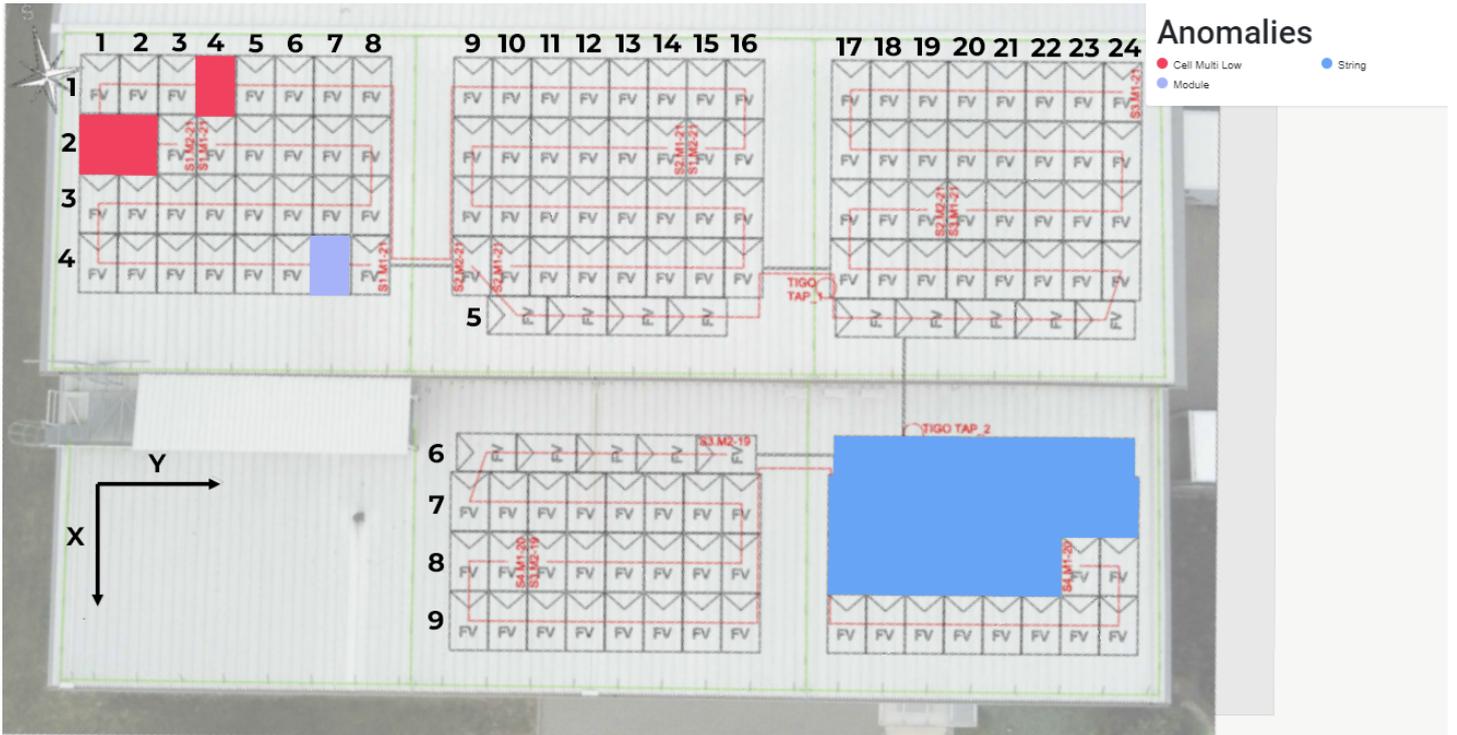
# Anomaly map

The following anomalies were found on the panels of the inspected photovoltaic power plant, with a total of **5 on 23 modules**.

The total estimated annual power loss is **9 245,00 kWh**.
